Manhole Inspection Summary

Manhole # S25C__022MH

Location Address: **501 CAREY ST**

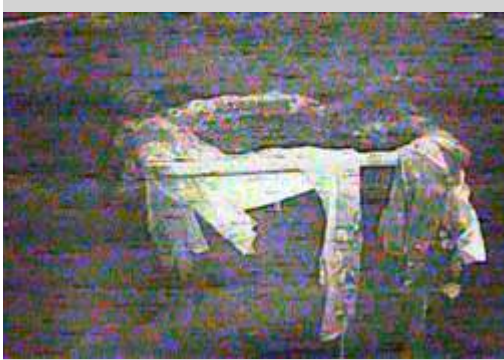
Defect 1

☒ **Evidence Of Surcharge**

Depth: **5** (ft.) ☐ Active Surcharge Present

SURCHARGE EVIDENCE

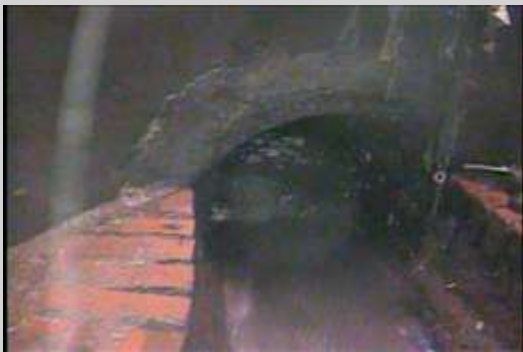
12 O'Clock Outflow

SURCHARGE EVIDENCE

Pipe Height: **19.2** (in.) Rod and Bar (Angled)
Pipe Material: **Clay** ☐ Pipe Lined
Invert Depth: **18.61** (ft.) Flow Characteristics: **Fast**
Deposits: ☒ None ☐ Mud ☐ Sludge ☐ Debris ☐ Grease
Silt Depth: (in.) Deposits Extent:
Infiltration: **None** Pipe Seal Cond: **Sound**

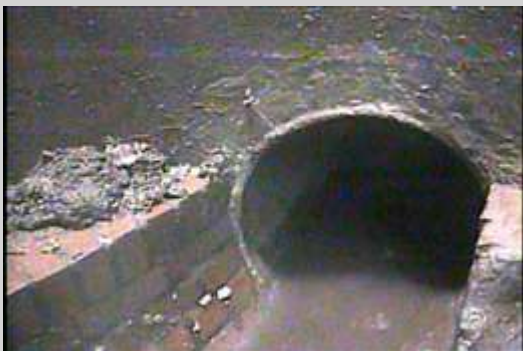
5 O'Clock Inflow

Pipe Height: **19.2** (in.) Rod and Bar (Angled)
Pipe Material: **Clay** ☐ Pipe Lined
Invert Depth: **18.50** (ft.) Flow Characteristics: **Fast**
Deposits: ☒ None ☐ Mud ☐ Sludge ☐ Debris ☐ Grease
Silt Depth: (in.) Deposits Extent:
Infiltration: **None** Pipe Seal Cond: **Sound**

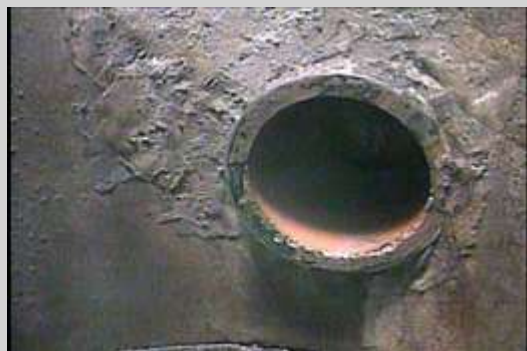
7 O'Clock Inflow

SURCHARGE EVIDENCE

Pipe Height: **10.8** (in.) Rod and Bar (Angled)
Pipe Material: **PVC** ☐ Pipe Lined
Invert Depth: **11.16** (ft.) Flow Characteristics: **Fast**
Deposits: ☒ None ☐ Mud ☐ Sludge ☐ Debris ☐ Grease
Silt Depth: (in.) Deposits Extent:
Infiltration: **None** Pipe Seal Cond: **Sound**

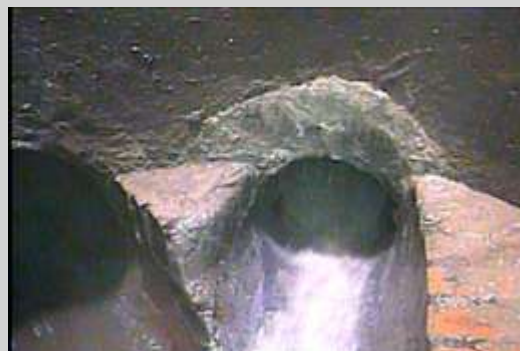
Drop In @ 7 O'Clock

SURCHARGE EVIDENCE

Drop: **Outside** Rod and Bar
Angled: **Yes** Reading: **16.93** (ft.)
Inv Depth: **17.93** (ft.)
Drop Condition: **Open**
